Manhole Inspection Summary

Manhole # S130__001MH

Insp Date: **3/24/08 10:07 AM**

Location Address: **410 Font Hill**

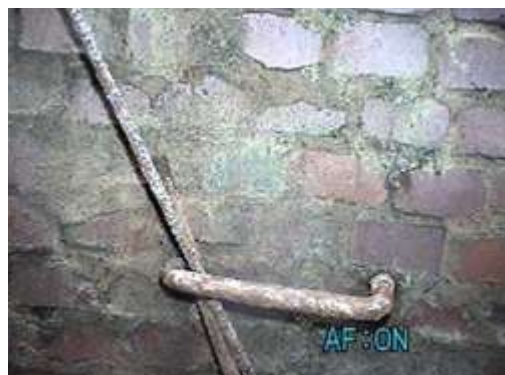
Defect 4

Infiltration: ☐ None ☐ Joint ☐ Cracks ☐ Mortar ☐ Roots ☒ **Wall**

signs of barrel infiltration at wall

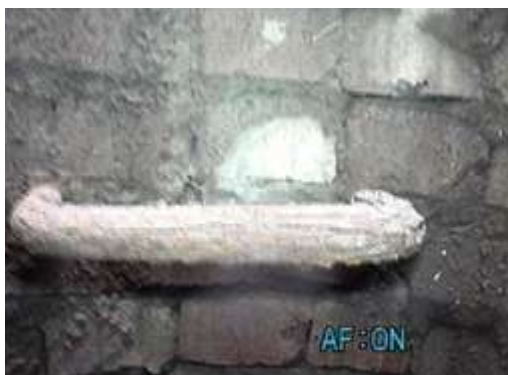
Defect 3

Count: **3** Missing: **0** ☒ **Corroded**

rusty rungs

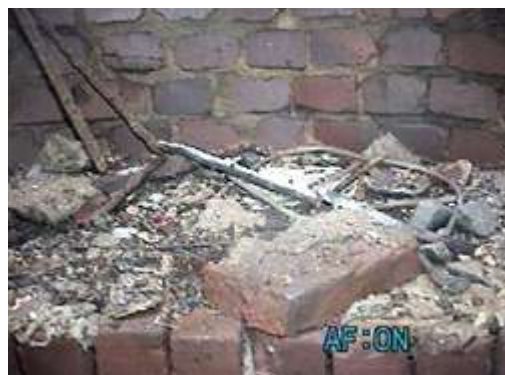
Defect 6

Condition: ☐ Sound ☐ Cracked ☐ Root Intrusion ☐ Deteriorated ☐ Leaks ☒ **Debris**

bench cond debris

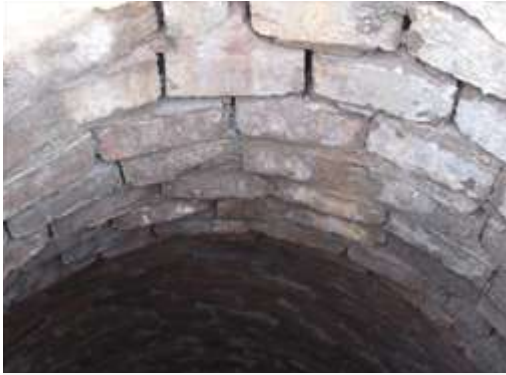
Defect 2

Condition: ☐ Sound ☐ Cracked ☐ Root Intrusion ☐ Loose Brick ☒ **Deteriorated**

Infiltration: ☐ None ☐ Joint ☐ Cracks ☒ **Mortar** ☐ Roots ☐ Wall

corbel deteriorated, infiltration at mortar

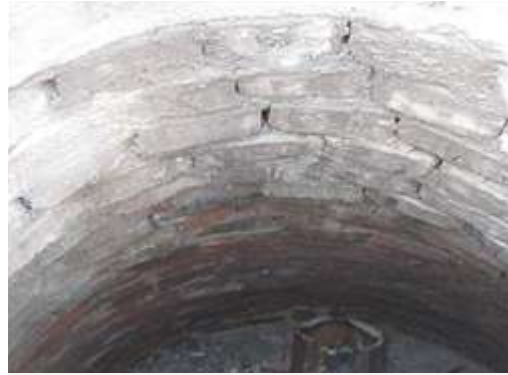
Defect 1

Condition: ☐ Sound ☐ Cracked ☐ Root Intrusion ☐ Loose Brick ☒ **Deteriorated**

Infiltration: ☐ None ☐ Joint ☐ Cracks ☒ **Mortar** ☐ Roots ☒ **Wall**

chimney deteriorated with signs of infiltration at mortar & wall

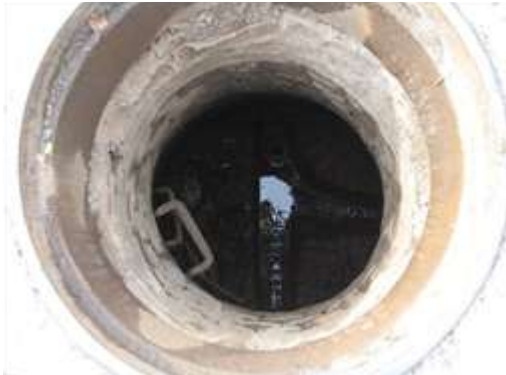
Defect 5

Condition: ☐ Sound ☐ Cracked ☒ **Leaks**

frame leaks - sheeting evidence

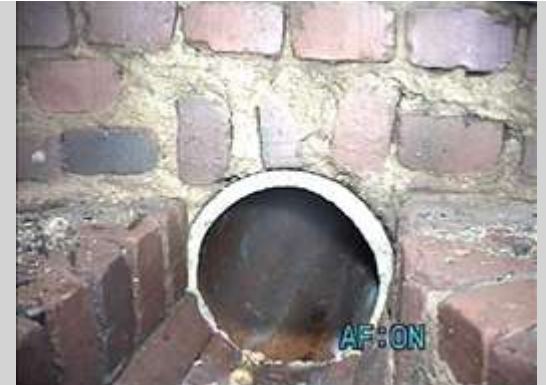
12 O'Clock Outflow

Pipe Height: **8.4** (in.) Rod and Bar (Angled)
Pipe Material: **Clay** ☐ Pipe Lined
Invert Depth: **9.20** (ft.) Flow Characteristics: **Fast**
Deposits: ☒ None ☐ Mud ☐ Sludge ☐ Debris ☐ Grease
Silt Depth: **0** (in.) Deposits Extent:
Infiltration: **None** Pipe Seal Cond: **Sound**

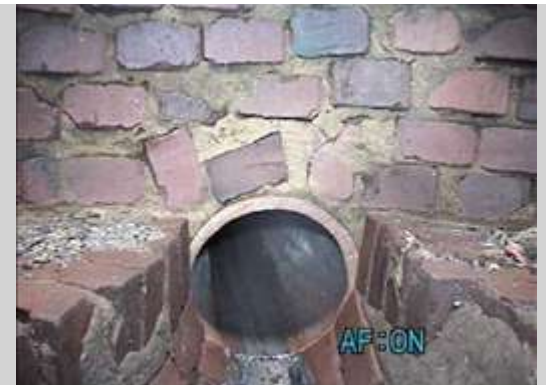
3 O'Clock Inflow

Pipe Height: **8.4** (in.) Rod and Bar (Angled)
Pipe Material: **Clay** ☐ Pipe Lined
Invert Depth: **8.44** (ft.) Flow Characteristics: **Fast**
Deposits: ☒ None ☐ Mud ☐ Sludge ☐ Debris ☐ Grease
Silt Depth: **0** (in.) Deposits Extent:
Infiltration: **None** Pipe Seal Cond: **Sound**

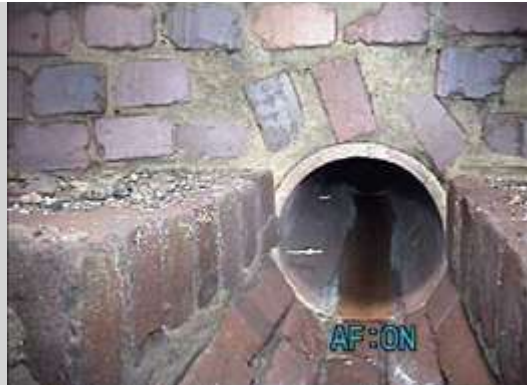
6 O'Clock Inflow

Pipe Height: **8.4** (in.) Rod and Bar (Angled)

Infiltration: **None** Pipe Seal Cond: **Sound**
